**Warren County Historical Society  
Electrical Evaluation  
210 Fourth Avenue  
Warren, Pennsylvania 16365**

## Struthers-Wetmore-Schimmelfeng House

The purpose of this study was to review the installed electrical, fire/security alarm, and communication systems within the building to determine if the systems are operating correctly and whether improvements should be made.

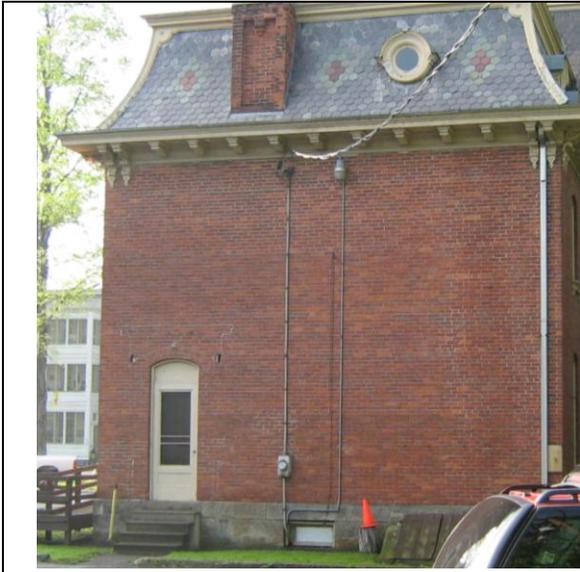
1. The existing electrical service is overhead from a pole at the property line to the meter on the building. The surface mounted mast, meter and cable extend down into basement through a window opening. The cable appears to be USD or some outdoor service entrance rated cable. There is no physical protection from damage.

The overhead service and area light are exposed and directly seen from parking.

- Replace the panel
  - Add capacity for cooling
  - Consider adding capacity for special events
  - Replace the overhead utility cable for phone and power. The new duct bank would require trenching and backfill. The grassy area along the West property line could be used for this purpose.

- Remove the meter from the north side of the building and move to the west lawn area away from the structure.
- Replace all wiring. Add outdoor receptacles. Add receptacles to all the various rooms to reduce the use of extension cord.

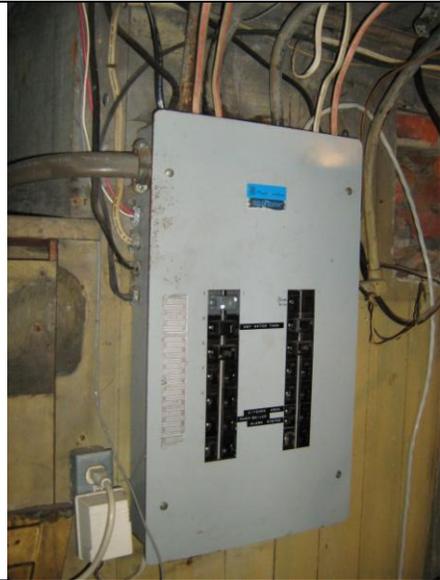
2. The main electrical panel is the only panel in the building and is old. The “pushmatic” type breakers are beyond useful life and parts are no longer supported.

This panel is located in the Basement and is obsolete.

The electrical distribution should replace the Pushmatic panel. An additional panel on the third floor may help with snow melting and adding circuits to the second and third floors.

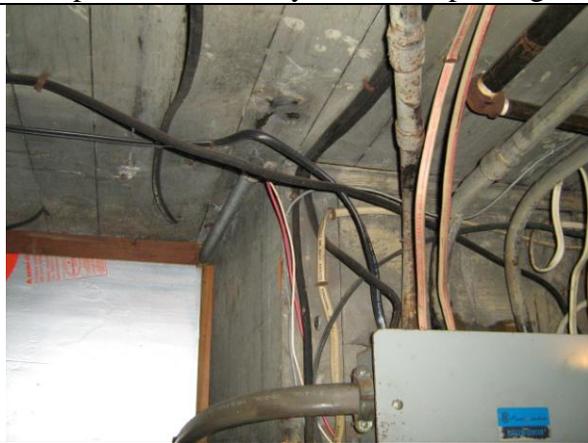
5. Due to the residential construction, the wiring is romex without a ground. The use of Romex in a commercial building is not permitted and further Code review should confirm the Use Group.

Branch circuiting is in Romex and other non-code compliant wiring methods

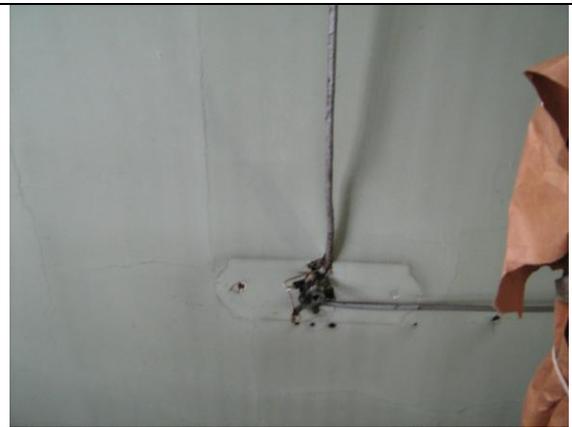
Open wiring and no fixture or box for splices.

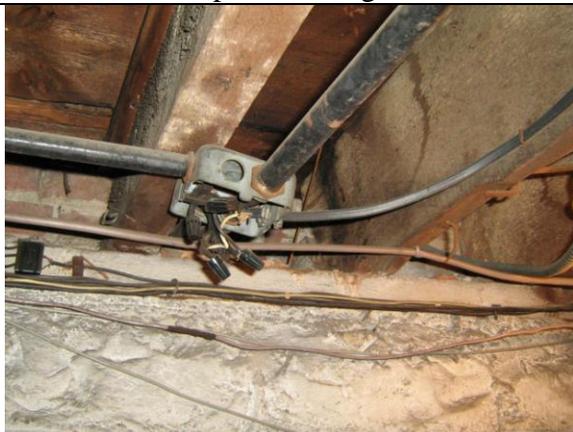
6. The amount of open junction boxes and splices in open air are numerous. The exposure to arcing faults and shock hazard for personnel is great
7. The existing wiring that is in the light fixtures is old and questionable for insulating value. The cloth covered single conductors have deteriorated throughout the years and are potentially hazardous. Cleaning or replacing lamps could compromise the insulation.

Open junction boxes and exposed wiring splices

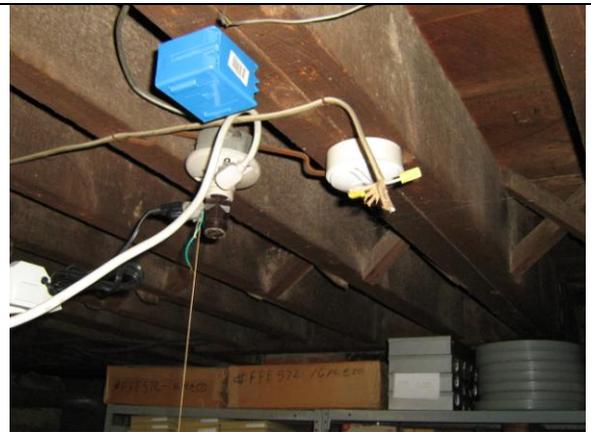
Energized cables not terminated properly and misuse of extension cords

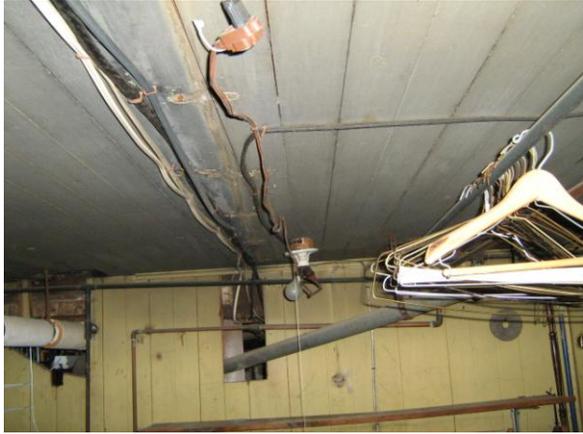
Extension cords are plugged end to end and using the lighting circuit for power

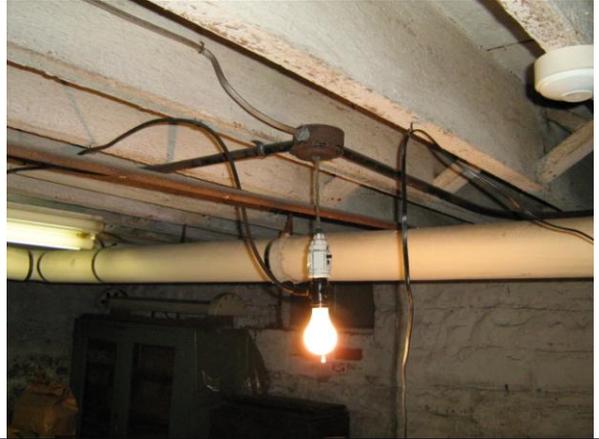
Socket extender and plug powers extension cords for portable appliances

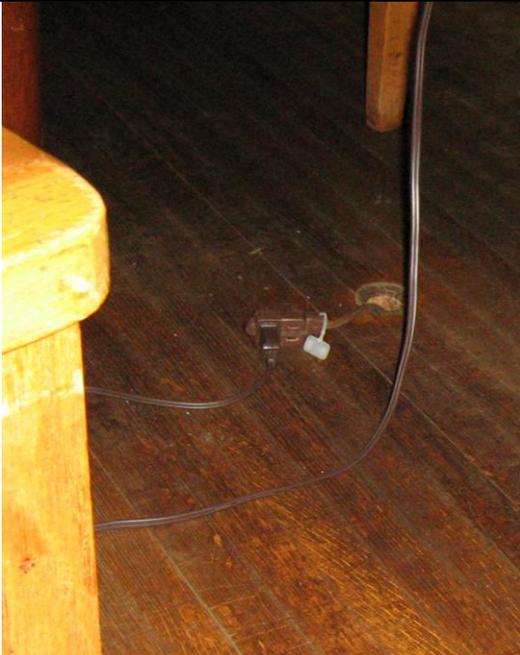
Cord penetrates from the basement to power the conference room table.

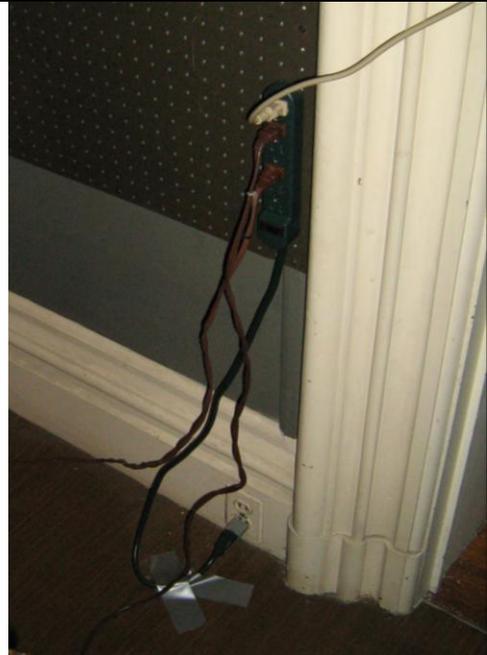
Cords and plugstrips are used to power lights in the hallway and for displays

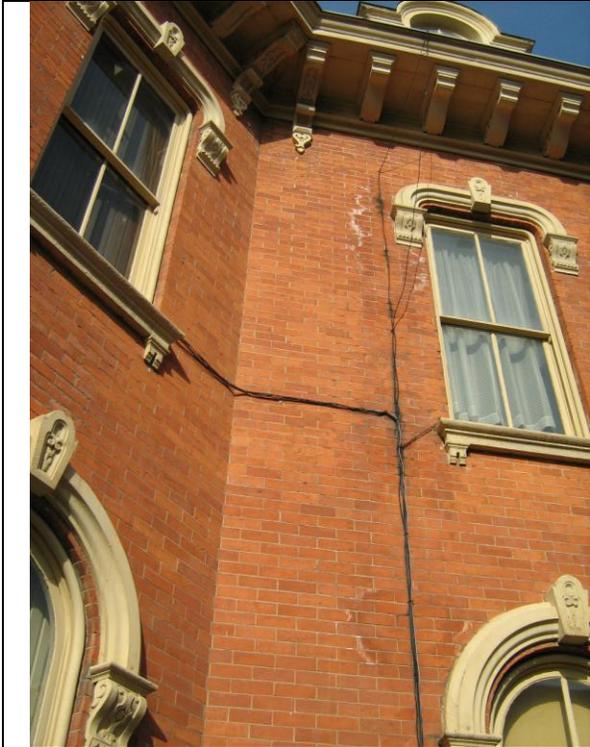
The exposed wiring on much of the building is abandoned. Wireless technology would help in allowing this to be removed.

- Remove all the tele/data cables that are abandoned on the outside
- Replace the building mounted area light. Exterior and accent lighting is needed
- Add dedicated snow melt cables for the roof and gutters

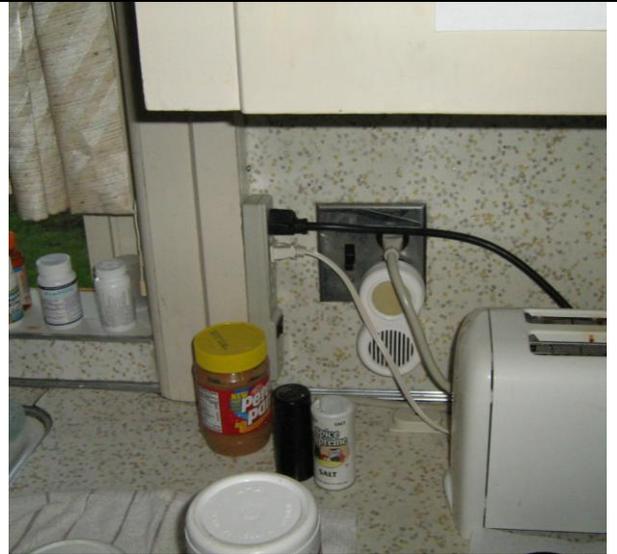
Kitchen outlet and multi-strip for counter appliances

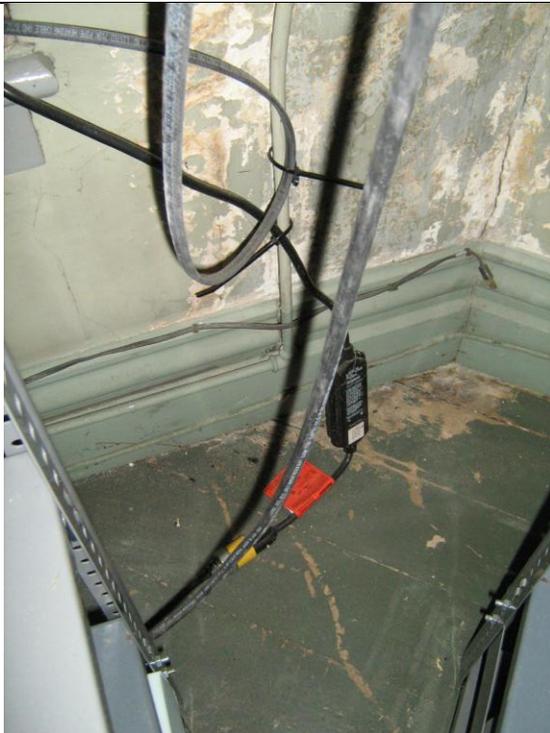
Snow Melt power cable penetrates the wall and enters the attic.

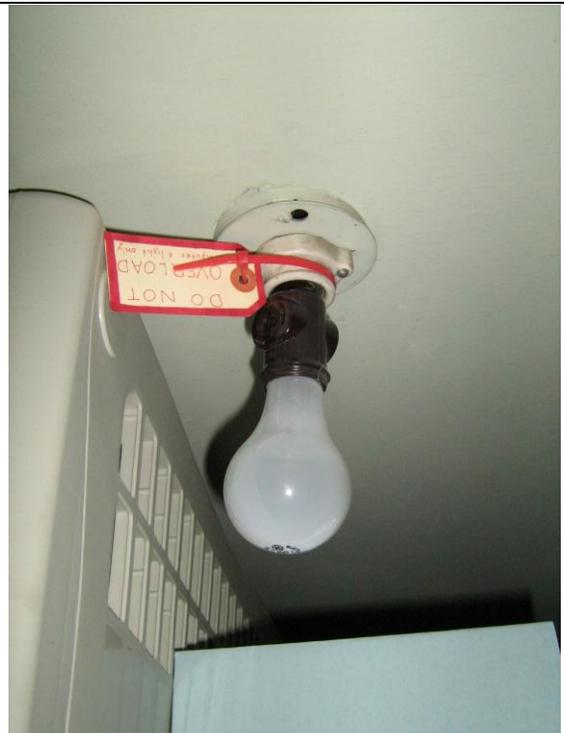
Socket extenders are labeled to prevent powering the snow melt cables.

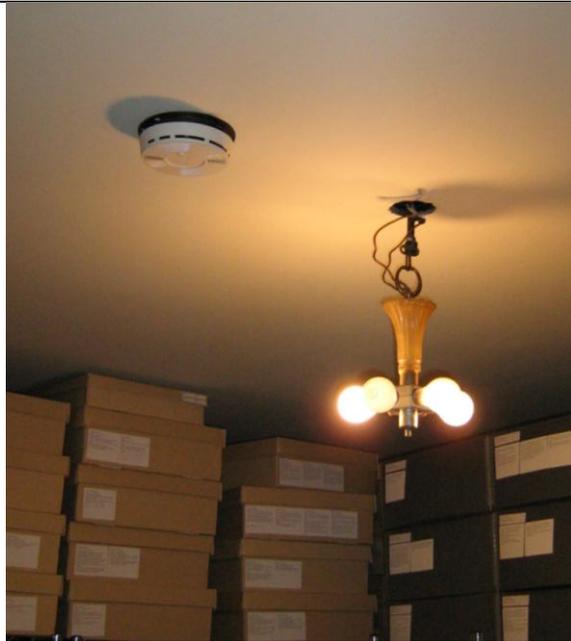
There are better fixtures for storage areas.

In general, the lighting is at the end of life and the energy saving would justify the replacement. As an example, the storage areas could be retrofitted with cost-effective strip fixtures. The new lights would be instant on, would require less maintenance and would use less energy. This better performance will result in a 2 to 3 year payback. It would be quicker but the limited use of these areas is factored into this estimate. Add occupancy controls in the stairways that maintain minimum safety standards but automatically switches most of the lights off.

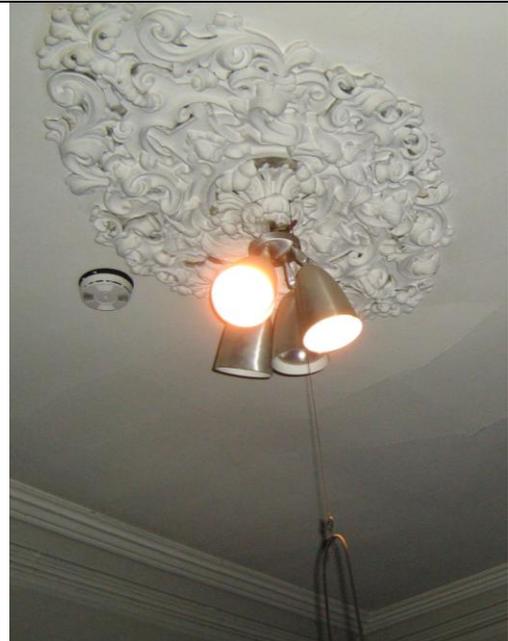
Fixture's appearance and performance are not consistent with the space. Mounting is not per Code.

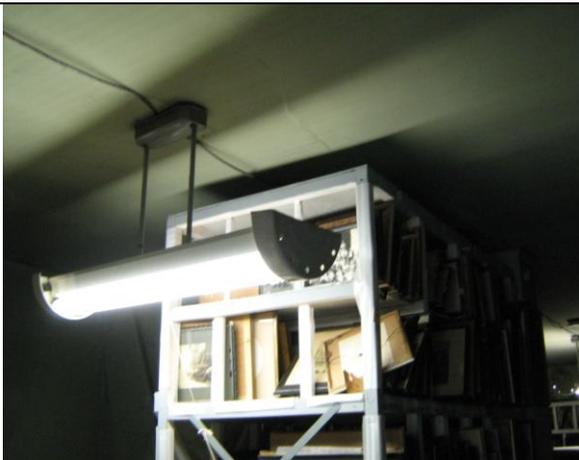
Fixture is very old and does not light all the time

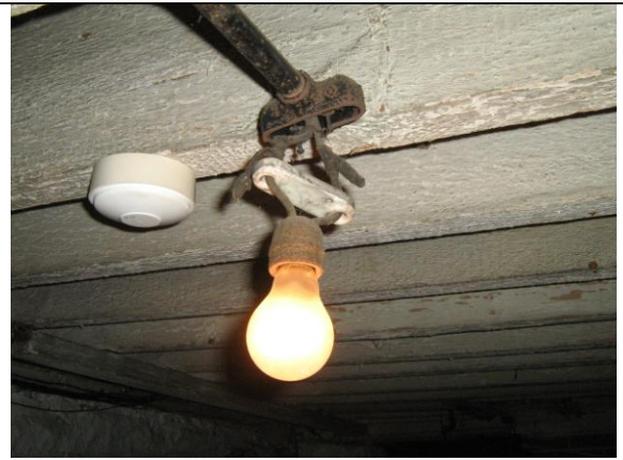
Light in the basement is not safe.

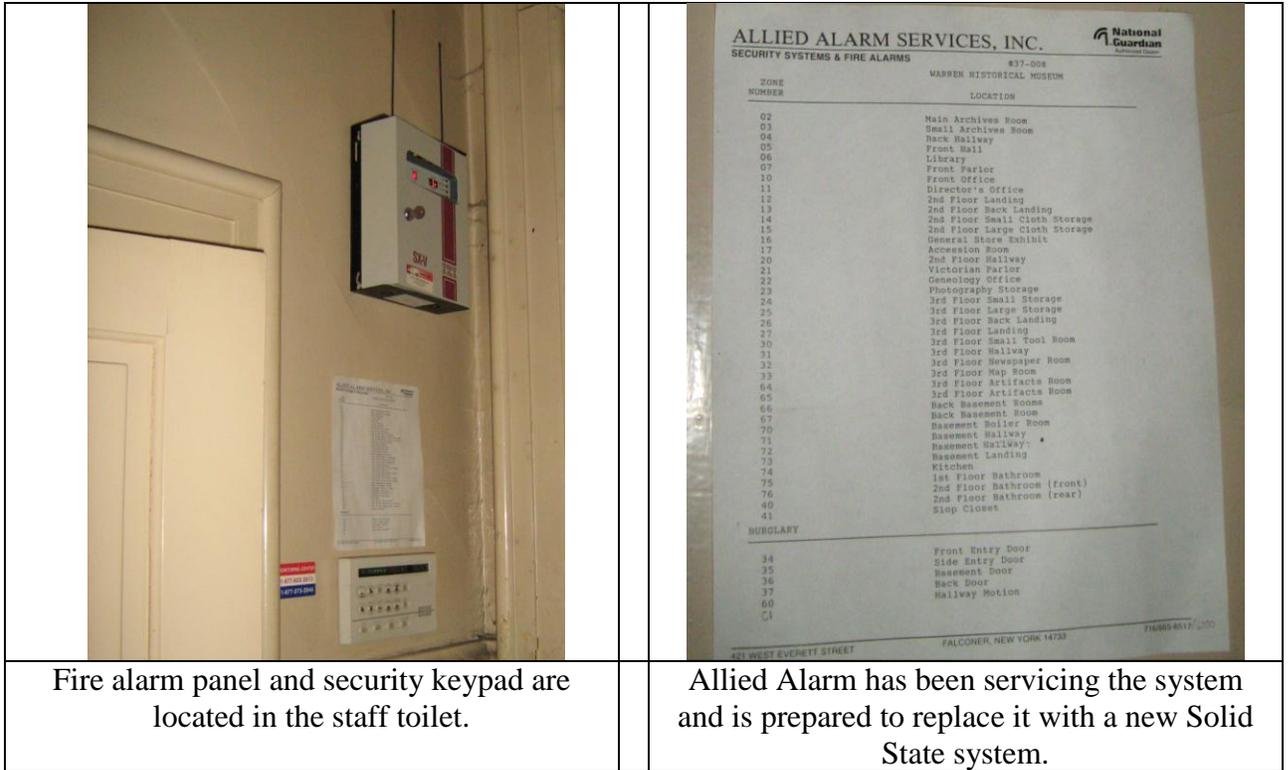
Fire alarm panel and security keypad are located in the staff toilet.

Allied Alarm has been servicing the system and is prepared to replace it with a new Solid State system.

The system should be fully tested and documented. A new dedicated fire alarm system should be budgeted to provide only the Life Safety function that saves lives. The new fire alarm systems provide improved detection and reporting while reducing false alarms. Proper locations and coverage should alert all occupant of a fire.
